HO-98

McLaughlin-Campbell-Laumann Building
8060 Main Street, Ellicott City

Historic Properties Form

Inventory No. HO-98

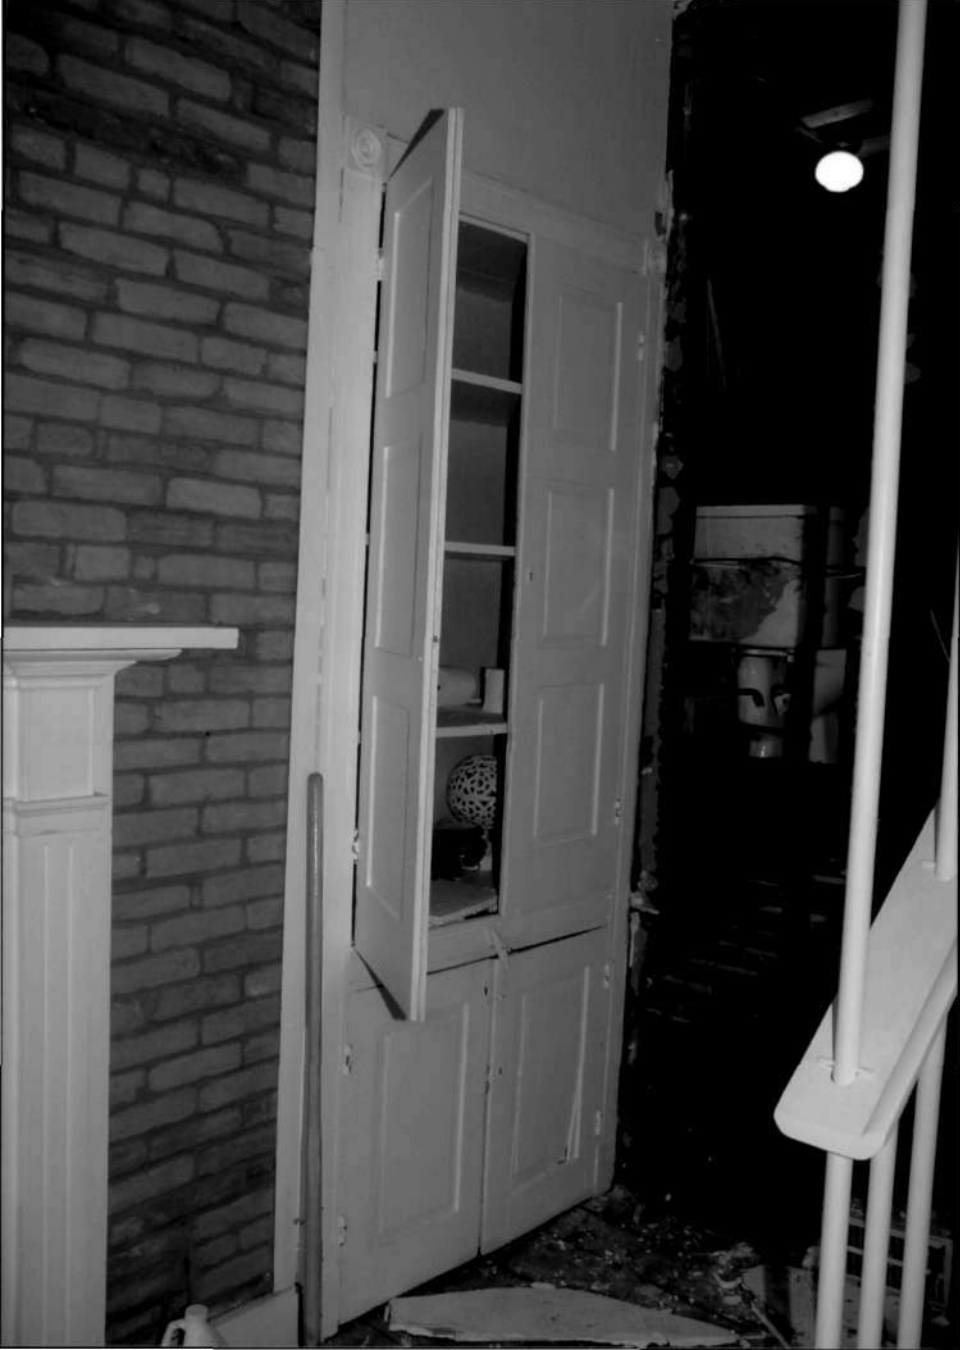
5 of 10

The back side of the cupboard has diagonal riven lath with plaster on the interior of the cupboard, and there is approximately 1 foot of space between the back of the cupboard and the west wall. The north side boards of the cupboard have cut nails coming through that must be original, and they have flat heads, not double-struck heads. At the north end of the east partition wall, under the stair landing, a stud is cut off where a door must have been cut through, since there is no header here. On the west wall, south of the fireplace, is a window opening framed into the wall, set close to the fireplace. The siding on the exterior beneath this window opening is sash-sawn, and the boards are flush on the interior. The exterior is not visible because a later stone building is built up against this wall. The interior of the window framing has plaster burns on it, and there is paint on the inner face of the opening. The west window outer frame has a bull nose, and the jambs have one rabbet for an outer stop, not a parting bead, as it is too close to the outer edge. There is evidence of two sash in the opening, with no gap between them on the jambs. The opening has board infill nailed with cut nails, with the stone wall of the adjoining structure behind this infill. There is a diagonal brace at the floor level, just south of the fireplace, which extends up behind the fireplace and must be the same brace visible behind the cupboard. This brace is on the interior face of the studs and had to be installed before the fireplace was erected.

West room, west elevation cupboard

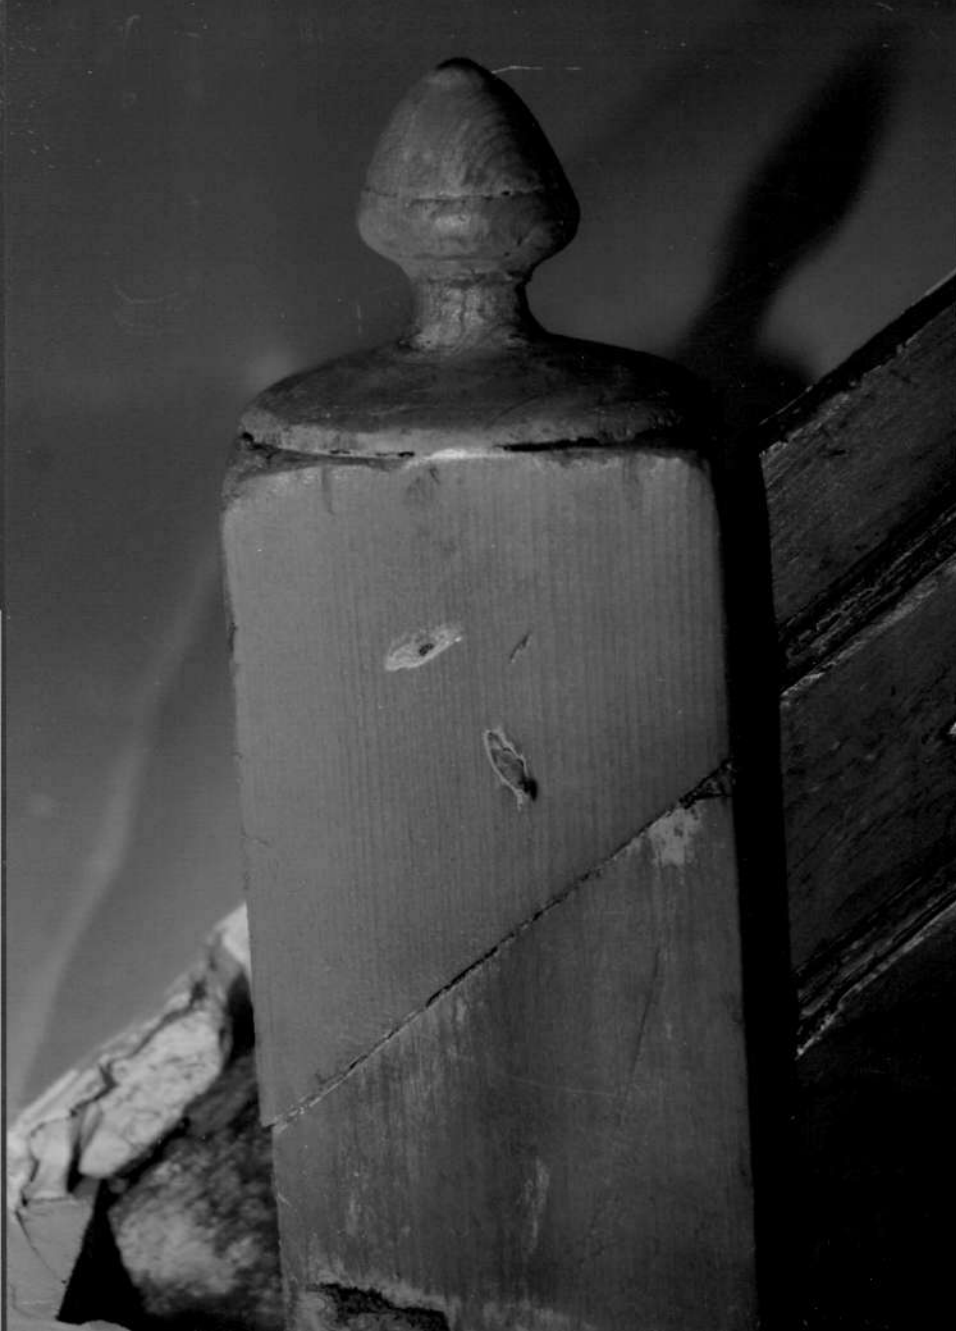
7 of 10

Stairway, newel drop pendant

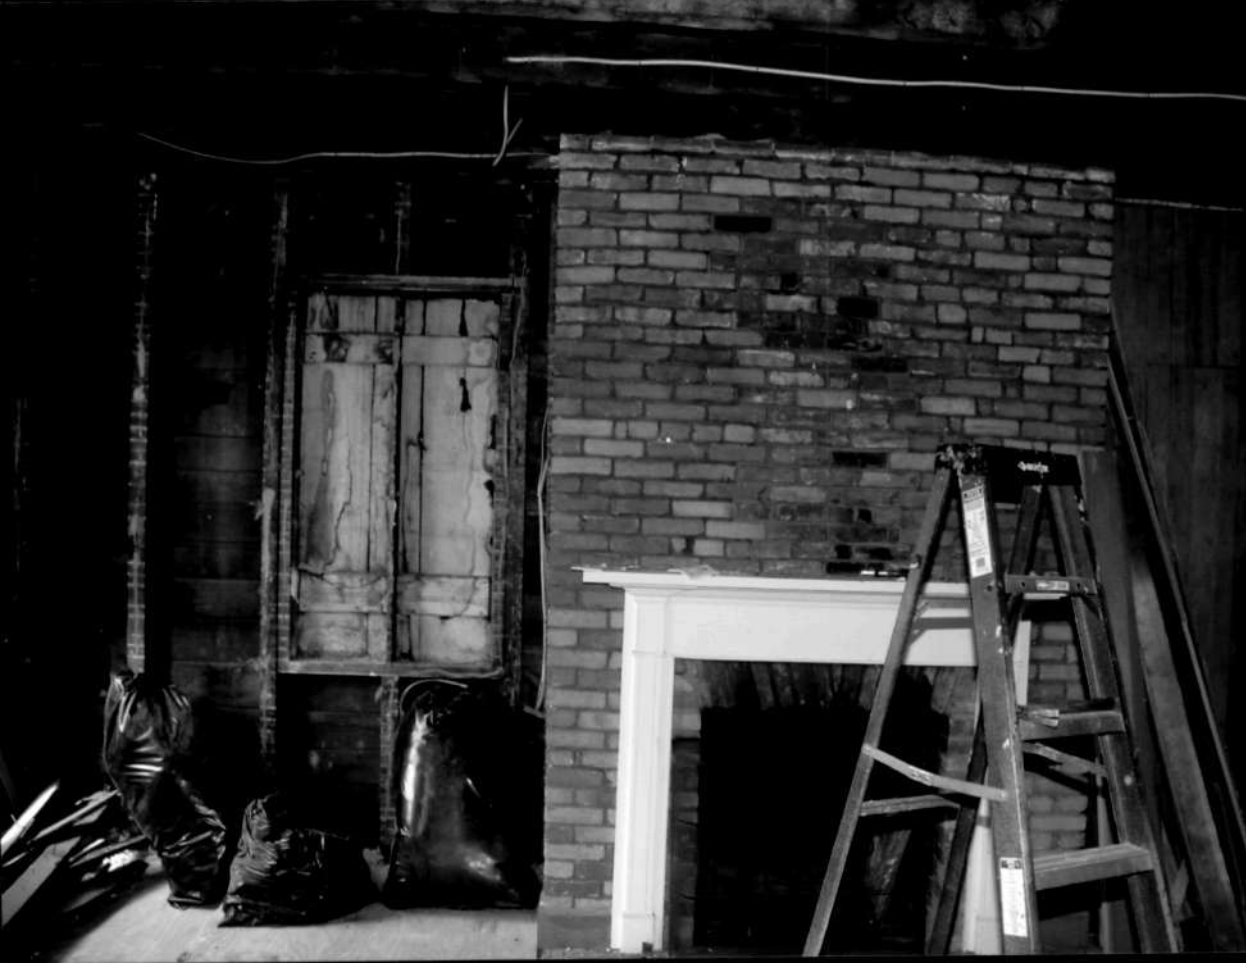
8 of 10

The west chamber has a fireplace centered on the west wall, with a new slate hearth, exposed brick, and a rebuilt firebox of firebrick with a splayed brick jack arch supported by an iron bar. There is a wood mantel with pilasters that have two rabbets, and it has a plain frieze and impost blocks. The pilasters

West chamber, west elevation

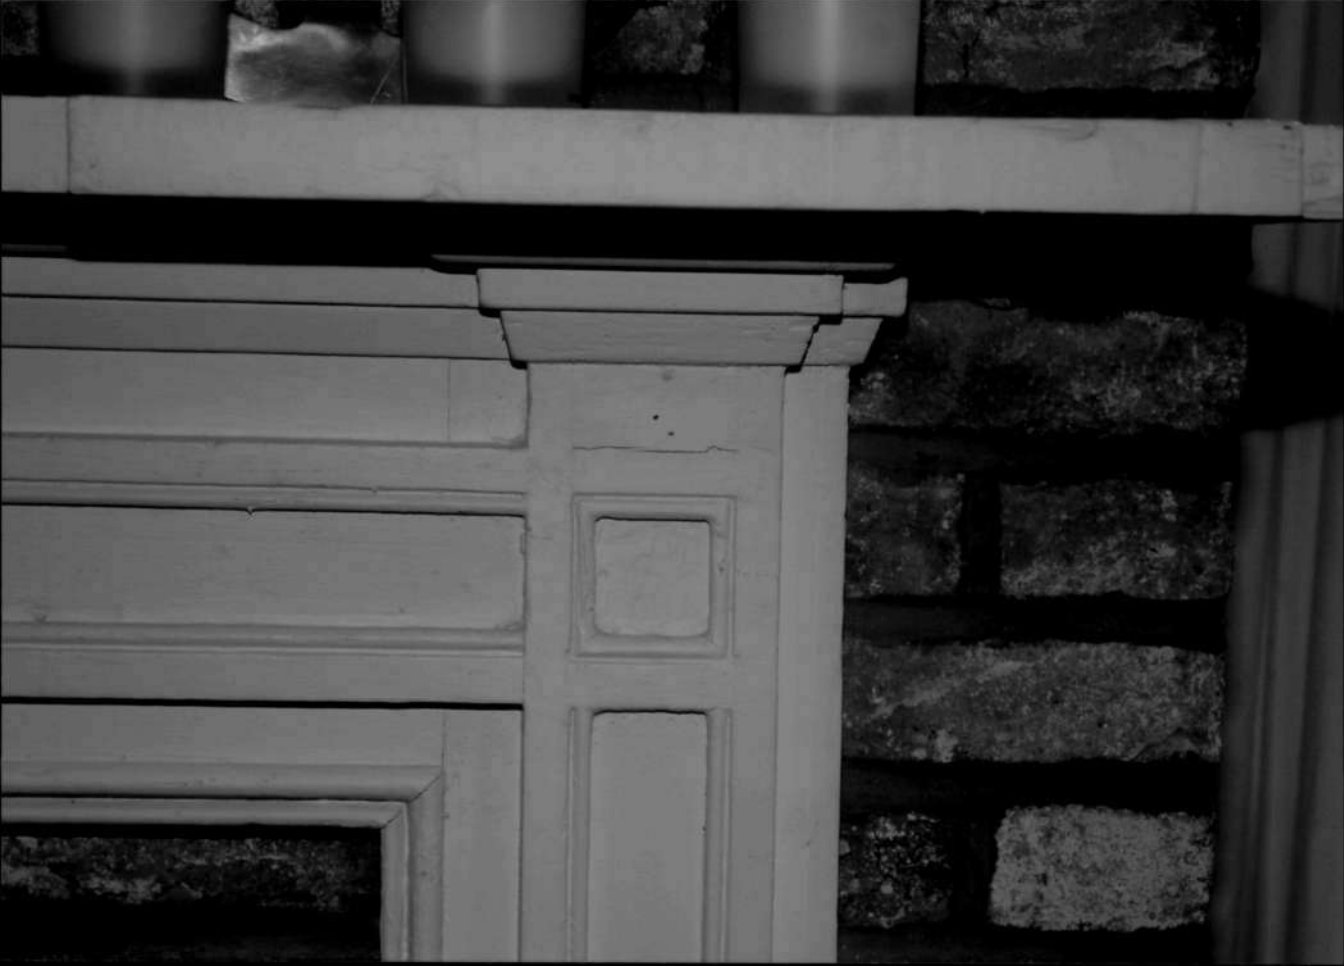
9 of 10

The east chamber has a fireplace centered on the east wall, with a new slate hearth, exposed brick, a rebuilt firebox, and it has a splayed brick jack arch. There is a wood mantel with paneled pilasters that are sunken and flat and have a bead panel mould. This treatment is also on the frieze, and there are corner blocks to match where the pilasters and frieze meet. The bed mould has a bead at the top, a fillet, and a bevel mould at the bottom. The shelf and bed mould break forward at the pilasters. This chamber has new baseboard, a new cupboard in the southwest corner, and a new window on the east elevation, south of the fireplace. There is some riven lath surviving on the north plate and behind the stairs. The studs are notched to take the landing joists.

East chamber mantel detail

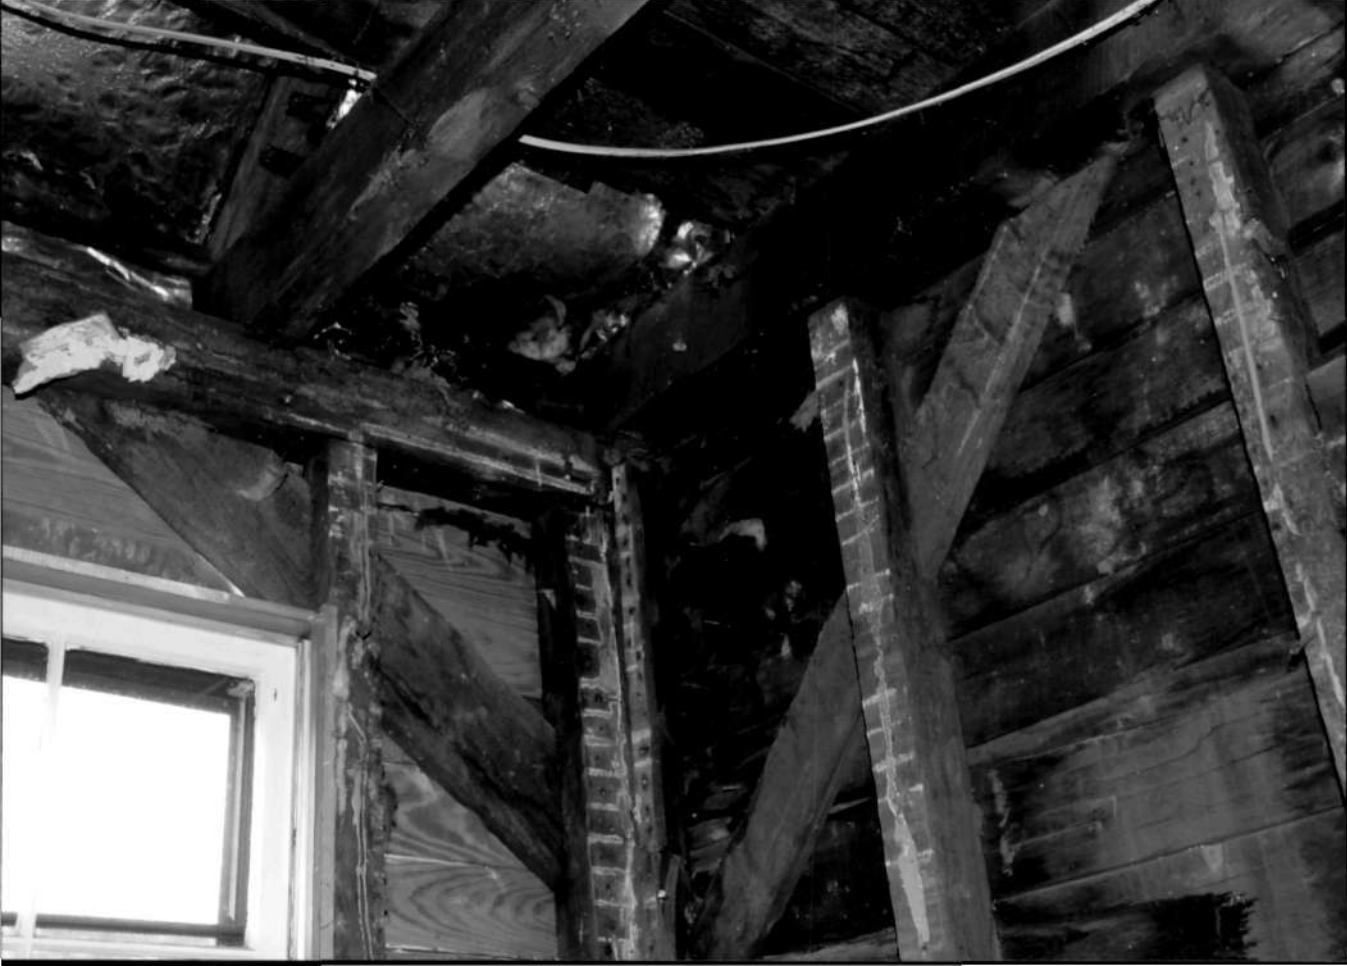
10 of 10

The frame is made from hewn timbers, many of which were then sawn to size, with two-story corner and intermediate posts connected with girts that are mortised and tenoned and pinned. This seems to be a traditional heavy timber frame, but there are many transitional features, some of which are surprising to see as early as 1831. The posts are only 4 inches deep, not surprisingly, in order to be hidden within the walls, but are all braced with skimpy 1 by 8s that are nailed to the posts with mature cut nails. No double struck nails were found in the building, suggesting a construction date after 1820. Exterior wall studs are mortised and tenoned between the sills and girts, or between the girts and plates, but are not pegged; some of them may be nailed. The stair headers in the second-story and attic floors are not mortised and tenoned, but simply butted and spiked. Simplified building practices such as this have not been observed in other frame buildings in Howard County this early, and it is possible that new techniques being used in Baltimore were brought to Ellicott City by McLaughlin and his architect for Angelo Cottage, Alfred S. Waugh. It is not known whether Waugh had anything to do with the construction of the house on Main Street, but McLaughlin was busy building an addition to the Patapsco Hotel, so he may have been hired for this and all of the work going on.⁵

Southwest corner wall framing
below attic floor level
